## A Day With Waldron

**Mr. Waldron Leard, 12 Heritage Lane, Kingsboro, PEI**

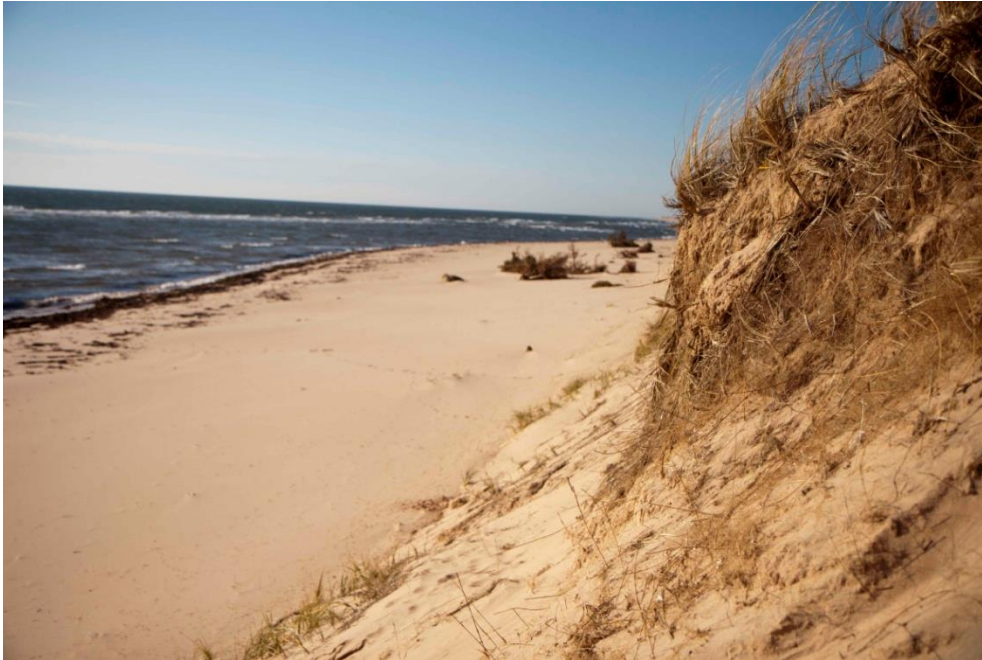
At Bothwell Beach, Waldron has observed a major shift in the sand dunes between last fall and Jan. 7<sup>th</sup>, 2011. Before Jan. 7<sup>th</sup> of this year, when a person walked down to the beach it was a flat area. After Jan.7<sup>th</sup> and on the date of our visit, a 20 foot high sand dune has appeared. This dune is still building in height with time. Some trees which have succumbed to a storm surge are now lying in the sand to the west of the beach access. The entrance to South Lake to the east of Bothwell beach has been changing. Waldron used to walk across to the barrier bar on the south side of the Lake at low tide when he was a boy. Today there is a channel which is 8 to 9 feet deep which would require one to swim over to the barrier bar. Summer home owners on

the inner side of South Lake have been experiencing shoreline erosion of 4 feet over a 4 year period.

Figure 3 - Bothwell Beach Dunes Storm Surge Debris, Nov. 10, 2011

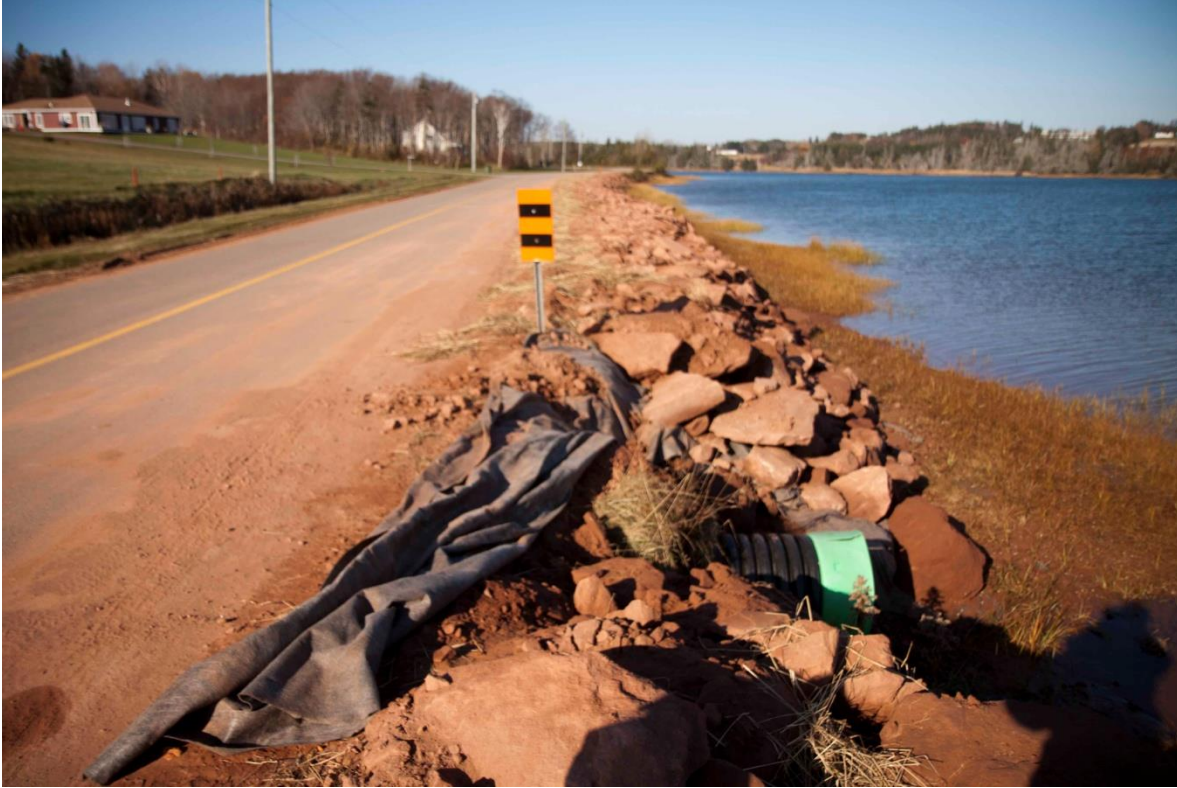
The road into Basin Head has been experience damage from storm surges and erosion in recent years. Repairs were made to the NE side of the road by the Dept of Transportation and Infrastructure Renewal this past summer. The material installed does not look to be robust and may encounter future erosion especially around the culvert area.

Figure 4 - Basin Head Access Road Shoreline Protection, Nov. 10, 2011 TIR

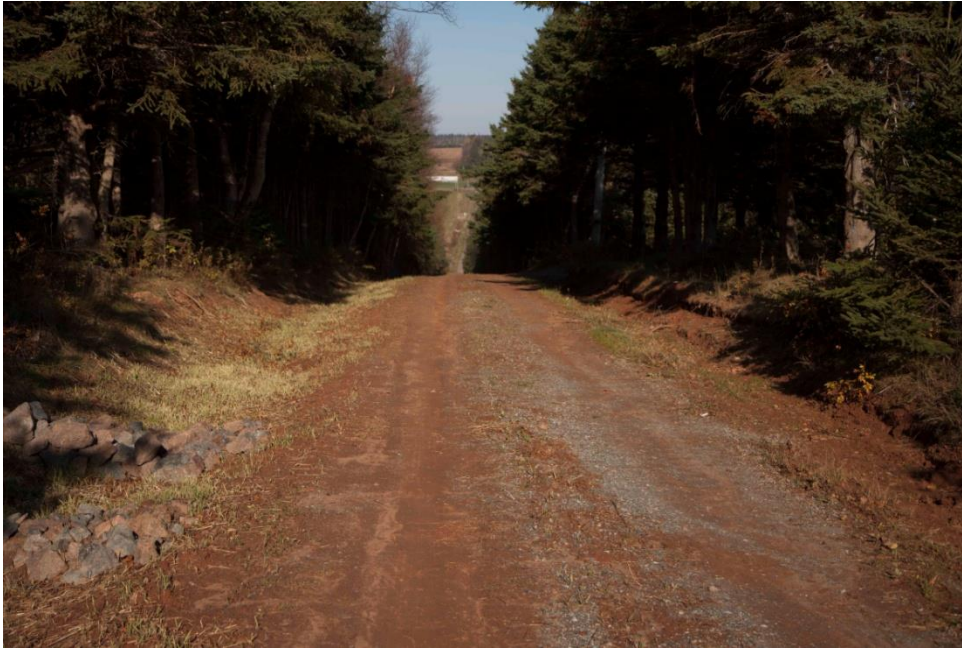
The steep hill at the beginning of the Young’s Hill Road has been the site of some erosion and siltation problems. Recent work has been done to divert some of the runoff water via side drain ditches and by gabions placed on both ditches of the road. Heavy runoff from intense rainfall events has been a factor in this area.

Figure 5 - Young's Hill Road - Red Point, Nov. 10, 2011

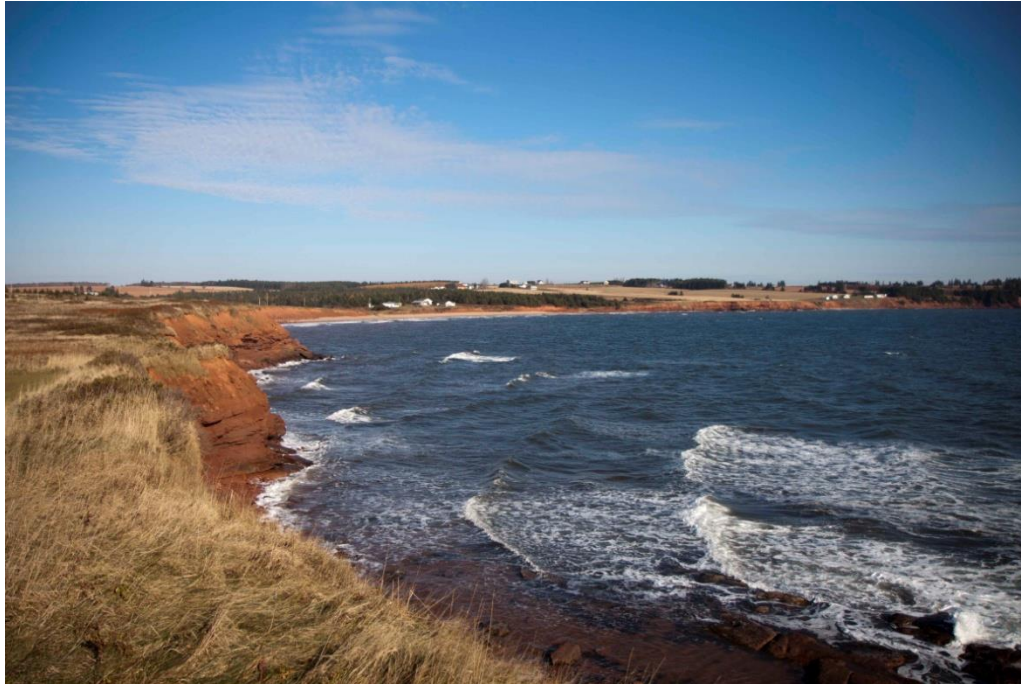
A summer home was placed at the end of this road on the point by a dentist a few years ago. This summer home may have to be moved in the future due to erosion and is an example of the need for better planning to prevent similar situations.

Figure 6 - Chepstow Shoreline, Nov. 10, 2011

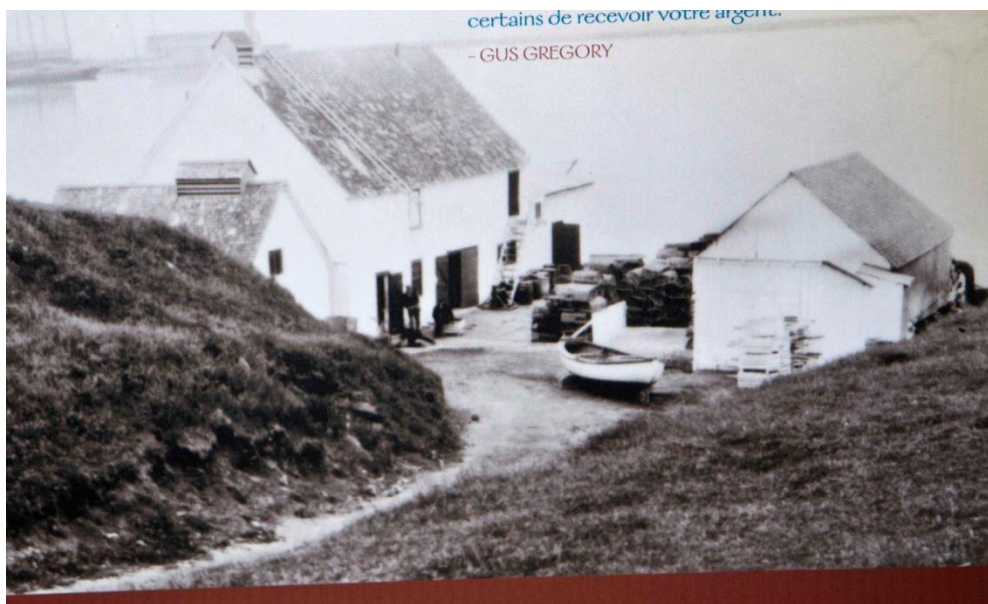
Figure 8 - Matthew MacLean Wharf early 1900's (from Matthew MacLean Museum)

There was a wharf located on the shore just south of the Fisherman’s Memorial. This wharf operated from the late 1800’s up to the 1940’s and was then abandoned. There is a photo of this site taken in the late 1800’s in the History Room in the Town on Main St. They abandoned this site due to storms and rising sea levels.

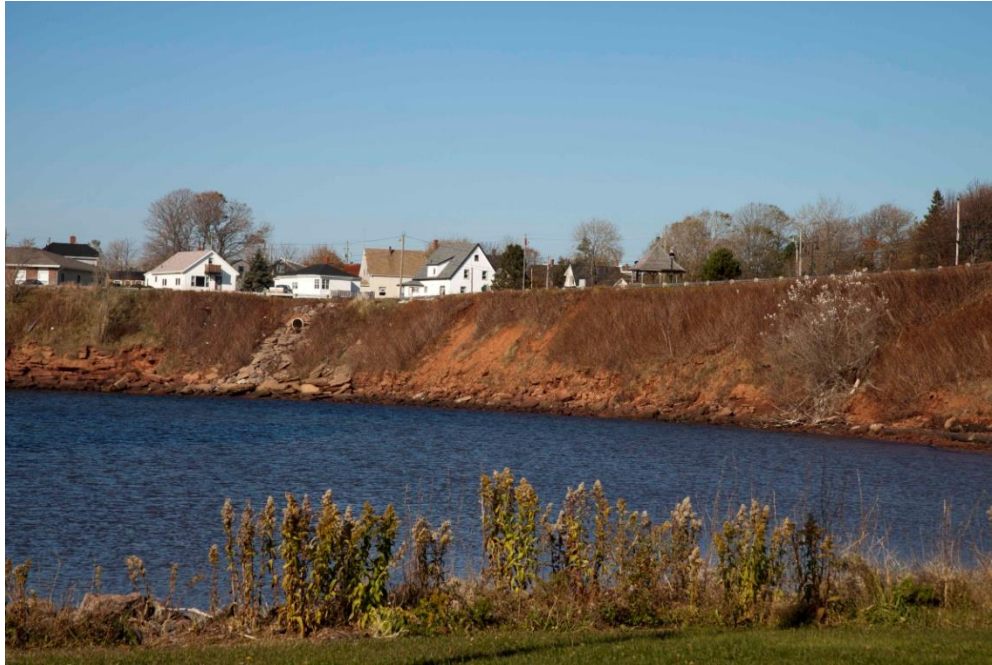
Figure 9 - Site of Matthew MacLean Wharf, Nov. 10, 2011

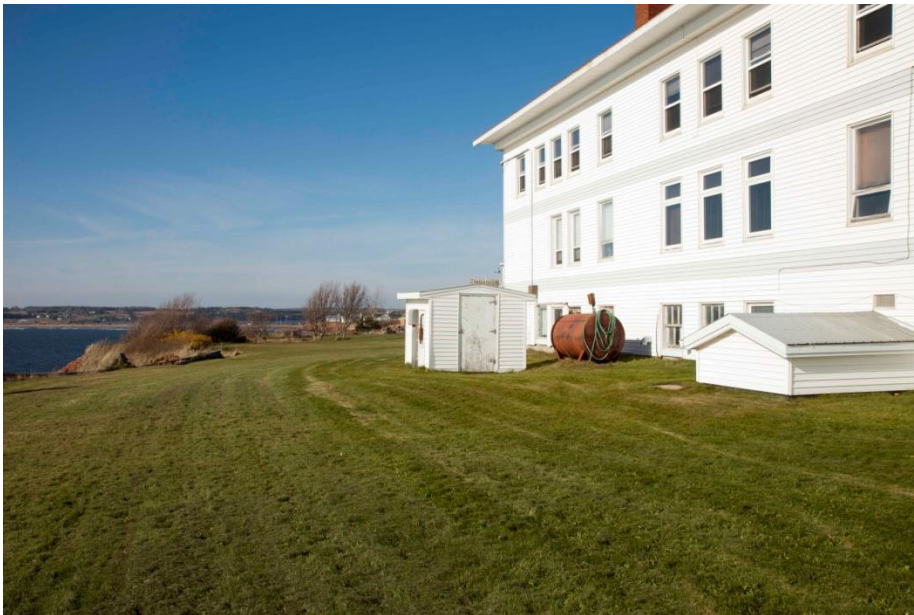
Waldron was born at the former Souris Hospital on Jan. 23, 1955. His mother recounted a story of watching an oil truck come to fill the oil tank on the shore side of the hospital. First the snow removal equipment came and then the oil truck drove behind the hospital, turned around and then filled the oil tank. Today there is not enough room for this to be done. Along the top of the cliff, we observed guard rail posts which are hanging in open air as the soil in which there were

placed has eroded and disappeared over the cliff. The former Souris Hospital at this location officially opened on August 8, 1945 and operated up to the late 1980's.

Figure 11 - Bayview Lodge - Former Souris Hospital - oil tank, Nov. 10, 2011

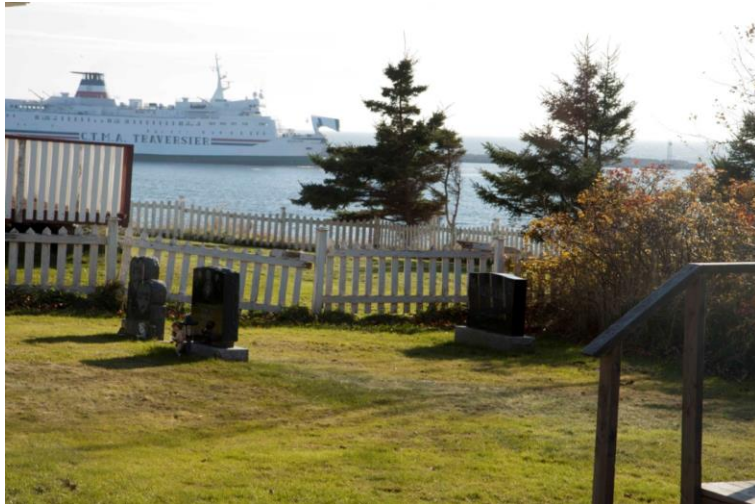
The small church building in the area was built in 1979 or 1980 at the south end of the cemetery. Some of the graves are getting close to the edge of the cliff and Mr. Leard believes that in 25 to 30 years, some of the graves may have to be exhumed to avoid them being exposed at the shoreline due to erosion. In this area, there used to be a street running parallel to the shoreline called Front St. This is shown in the 1880 Meacham's Atlas. This street no longer exists.

Figure 13 - St. Alban's Cemetery – Nov. 10, 2011

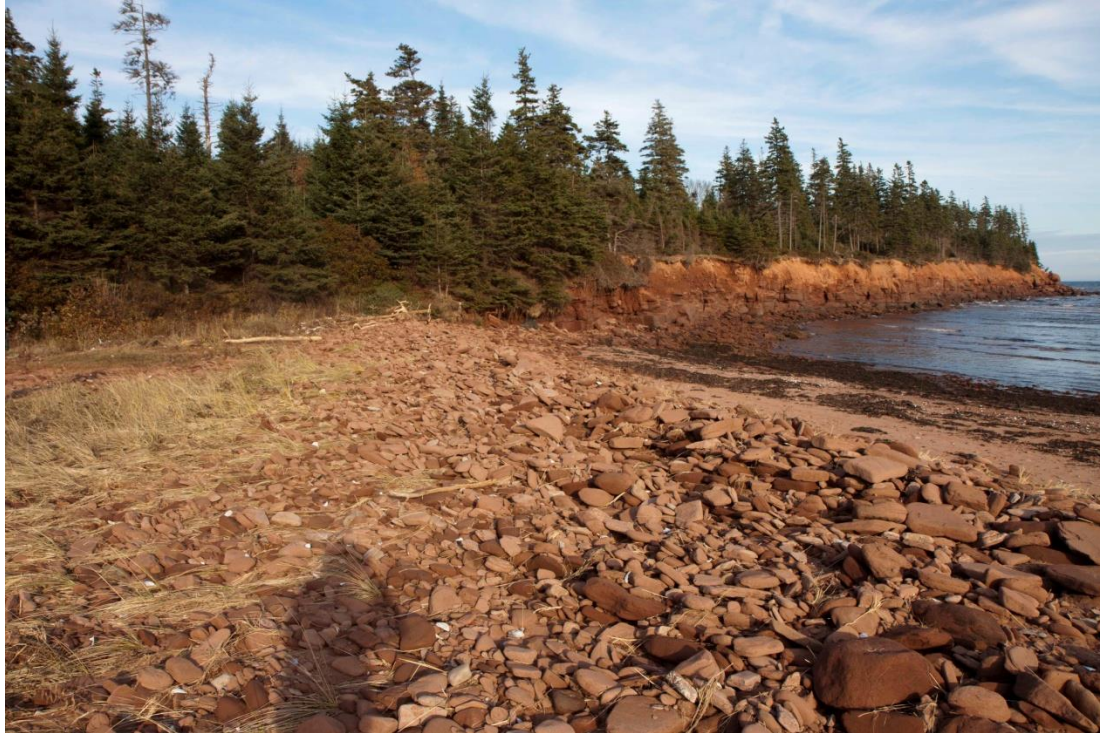
Waldron recalls going to a high school graduation party at this beach. He recalls that the area was all sand in 1974 but today there is a lot of sandstone cobble and evidence of erosion in the area. He believes that over 20 feet of shoreline has been lost in the area since 1974.

Figure 16 -  
Abell's  
Cape Bay  
Fortune,  
cobble  
beach—  
Nov. , 10,  
2011

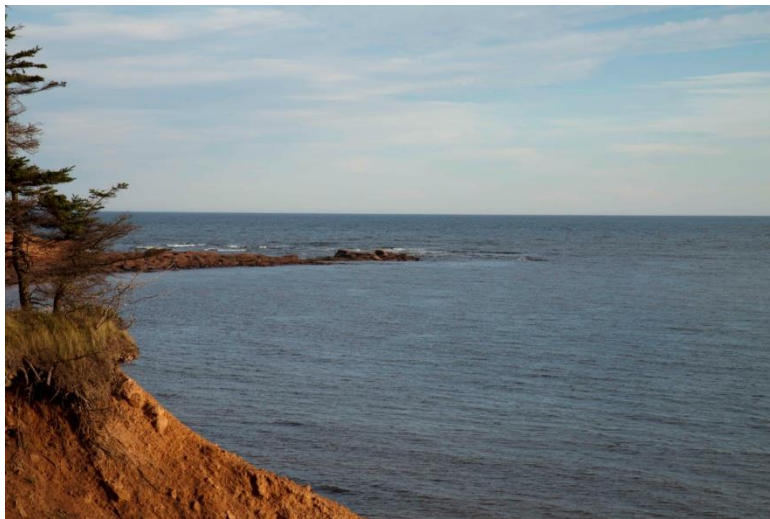
Waldron recalls taking a photo in 1981 of a hand dug stone lined well which was approximately 3 feet in diameter which could be seen at the end of Spry Point. This well protruded out of the water by several feet and was evidence that there was a home in the area at one time. This stone lined well collapsed about 8 to 10 years ago. He estimates that 200 metres of land may have eroded away in this area up to the current day.

Figure 17 - Spry Point, Nov. 10, 2011

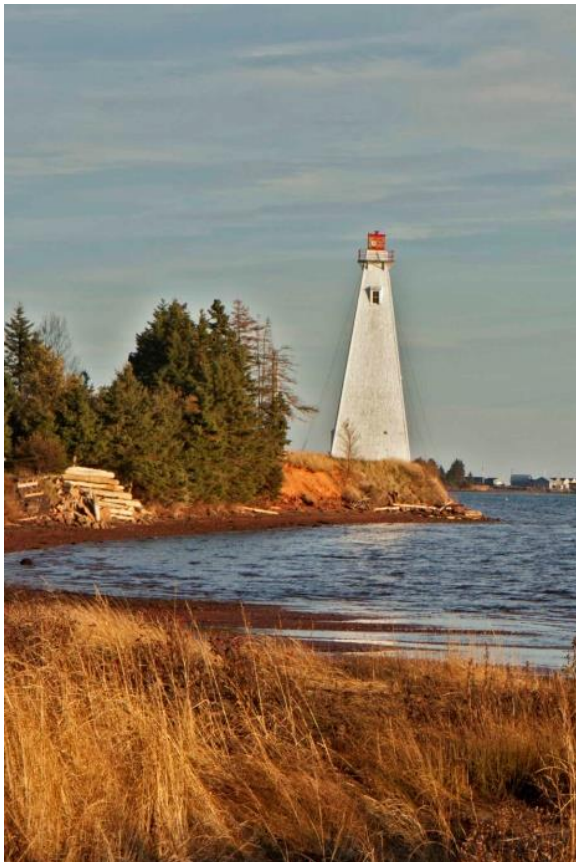
We drove to the end of the Lighthouse Road in Avondale and observed the lighthouse at the edge of the cliff. Some of the support cables for the wharf appear to be in the water. There is evidence of some wooden cribwork shoreline protection along the shoreline at this lighthouse in a 2006 photo on

Waldron believes it won't be long before this lighthouse falls over the cliff after a storm unless something is done to protect the shoreline in the area.

Figure 18 - Annandale Light House – Nov. 10, 2011
